# Case Studies in Engineering Failure Analysis

# Failure analysis of mixed mode crack growth in heavy duty truck frame rail

A failure analysis investigation was performed on a fractured heavy duty truck frame rail obtained during endurance track testing. The fracture observed was on the frame web within the torque rod connection to the rear drive axle of the vehicle. This section of frame experiences multi-axial loading conditions including out-of-plane bending, twisting and shear under road loads. Metallographic examination revealed micro-cracks on the edges of an open hole located in an area of high stress concentration. This manufacturing defect acted as a stress raiser and resulted in fatigue crack initiation. Simulation of crack growth on frame rail using dynamic loads from a full vehicle model was completed. After careful analysis it was concluded that the failure occurred due to an aggressively drilled open hole which created small crack initiations in a high stress-state location of the frame. This resulted in extensive curvilinear crack growth under dynamic loads of the vehicle.

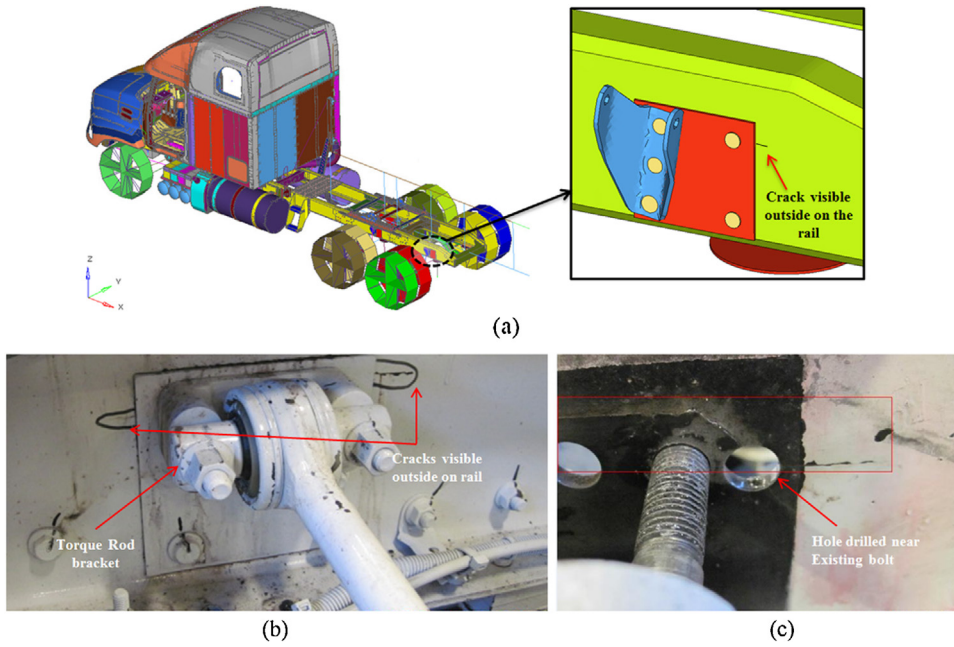
During a full vehicle endurance test repeated inspections were carried out after every few cycles of testing, after certain test cycles frame fatigue cracks were noticed during inspection near the rear drive axle torque rod connection of the vehicle. Fig. 2(a) shows the layout of the vehicle and the area of failure noticed on the vehicle. In Fig. 2(b), the torque rod bracket attachment to the inner web of frame with a reinforcement plate is shown. There were visible cracks on the frame extending behind the reinforcement plate and on either side of the torque rod bracket. In Fig. 2(c), the reinforcement plate bolted on both inner and outer section of frame was removed to view the crack path. This shows a bolt-hole being drilled near an existing bolt and cracks originating from this location.

Fig. 2. (a) Full vehicle layout and failure location. (b) Frame cracks visible near torque rod connection. (c) Crack path visible on frame behind outer reinforcement plate.

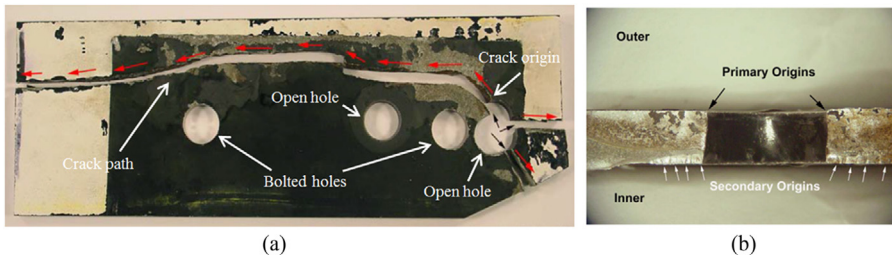
Fig. 3(a) reveals the complete range of failure with the crack path taking a curvilinear route behind the reinforcement plate and multiple cracks originated at the open drilled hole. It was observed there were two open holes present close to bolted holes and the presence of open holes were not realized during testing with the reinforcement plate installed. The open hole in the middle did not seem to affect the crack growth and was observed to be present in a low stress area. A closer view of exposed crack surfaces shows primary and secondary failure origins in Fig. 3(b). In Fig. 3(b), beach marks were identified and this indicated a fatigue failure mechanism.

Fig. 3. (a) Complete crack propagation directions on frame section. (b) Failure origin on analysis.

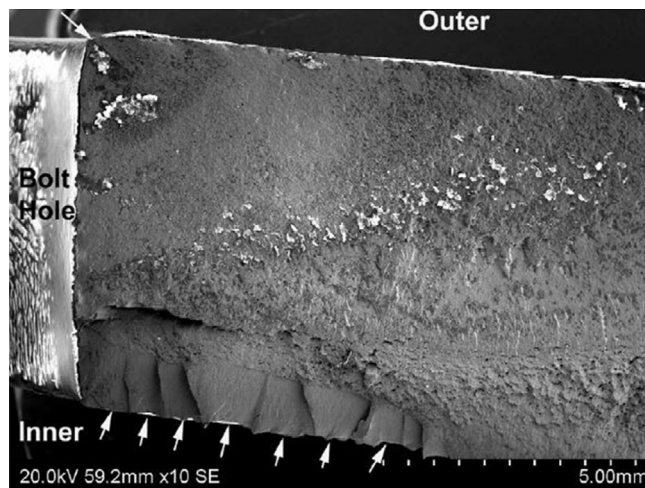
Fig. 4 shows primary crack initiations originated at the edge of the bolt hole and the secondary crack initiations originated on the inner surface of the frame adjacent to the bolt hole. In Fig. 5(a), a low magnification SEM image shows the beach marks (above the red dashed lines) indicative of a fatigue crack growth mechanism. Fig. 5(b) shows higher magnification optical micrograph image of the cracks on the bolt-hole wall which resulted from the aggressive hole drilling process.

Fig. 4. Crack origins on inner and outer surface.

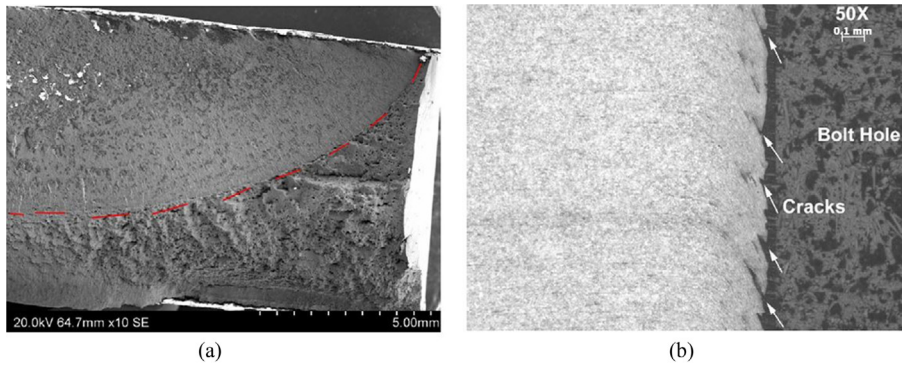
Fig. 5. (a) SEM image showing beach marks. (b) Optical micrograph showing cracks on the wall of open hole.

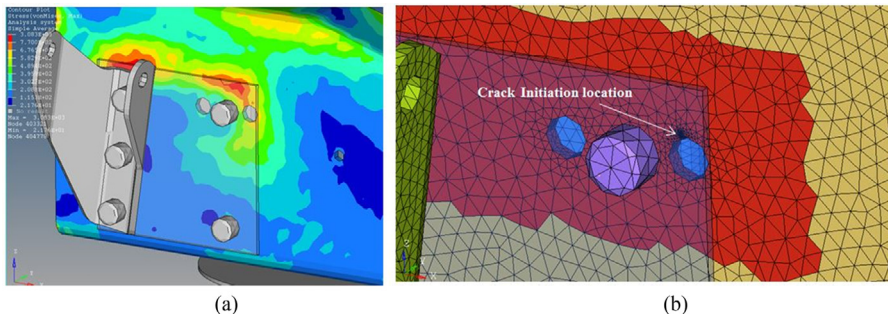
Fig. 7(a) shows von-Mises stress plot on the frame using full vehicle response dynamic loads. The stress obtained exceeded material yield strength at the open-hole and near the crack path obtained in physical test. A fatigue analysis for the duty cycle of test track events provided a damage value of “1.1” with the acceptance criteria being “0.5”. Fig. 7(b) shows FRANC3D meshed model with a small semi-elliptical crack (0.5 mm) inserted at the edge of open-hole and located in an area of high stress concentration. The size of the initial crack inserted was chosen assuming the surface cracks inserted during aggressive drilling process will grow to that size in few loading cycles and crack growth from there onwards was of primary interest.

Fig. 7. (a) Von-Mises stress plot obtained on frame. (b) FRANC3D model with initial crack location.

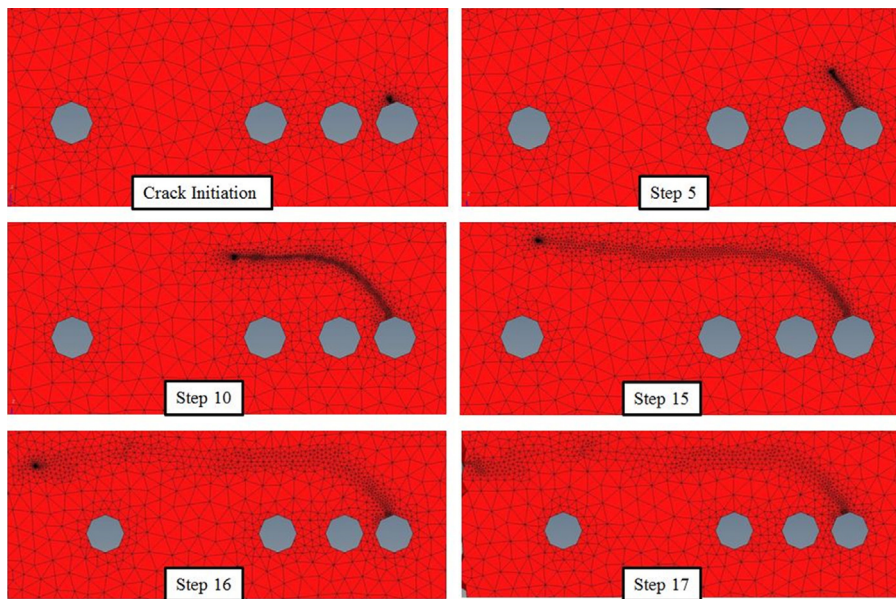
Fig. 8. Crack growth steps showing crack extension on frame.

In Fig. 8, crack growth history is shown where each step requires computing stress intensity factors (SIF) after growing the crack in FRANC3D and using NASTRAN solver for finite element analysis. The loads used for crack growth simulation were from full vehicle response dynamic loads and the 3D crack growth was chosen to be for constant amplitude fatigue type. The crack kink angle was determined using the strain energy release rate method. The well-known “Paris law” was used for fatigue growth rate model and the coefficients for Paris law were obtained from the frame supplier [10] (coefficient  $C = 6 \times 10^{-8}$ , exponent  $m = 2.26$ ,  $K_{\text{threshold}} = 316.2 \text{ MPa} \sqrt{\text{mm}}$ ). Stress intensity factors (SIF) were computed using the “Interaction Integral” (M-Integral) method and include effects of crack face contact and crack pressure.

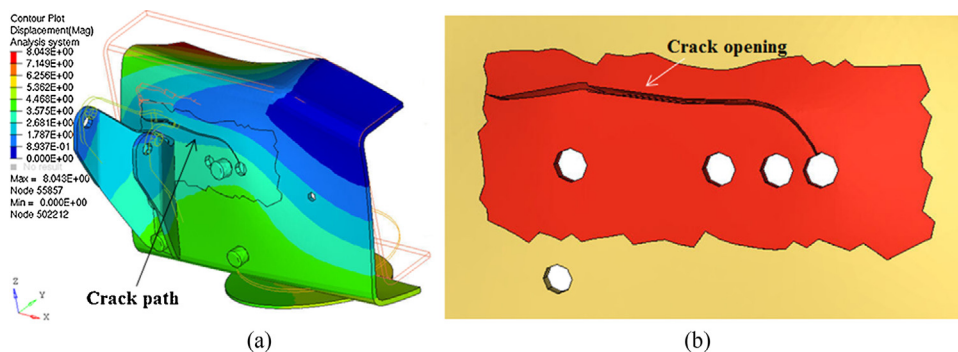
The damaging loads identified were primarily from vehicle turning events which results in rear drive axle torque rod pushing the torque rod bracket into the web of frame section, causing an out-of-plane bending as shown in Fig. 9(a). This out of plane bending loads causes any cracks present on the outer frame surface to open and grow under Mode I type crack growth behavior. Fig. 9(b) shows crack opening (scaled 10 times) at step 17 under out-of-plane bending loads on frame.

Fig. 9. (a) Out-of-plane bending of frame during turning event. (b) Crack opening under frame bending loads.

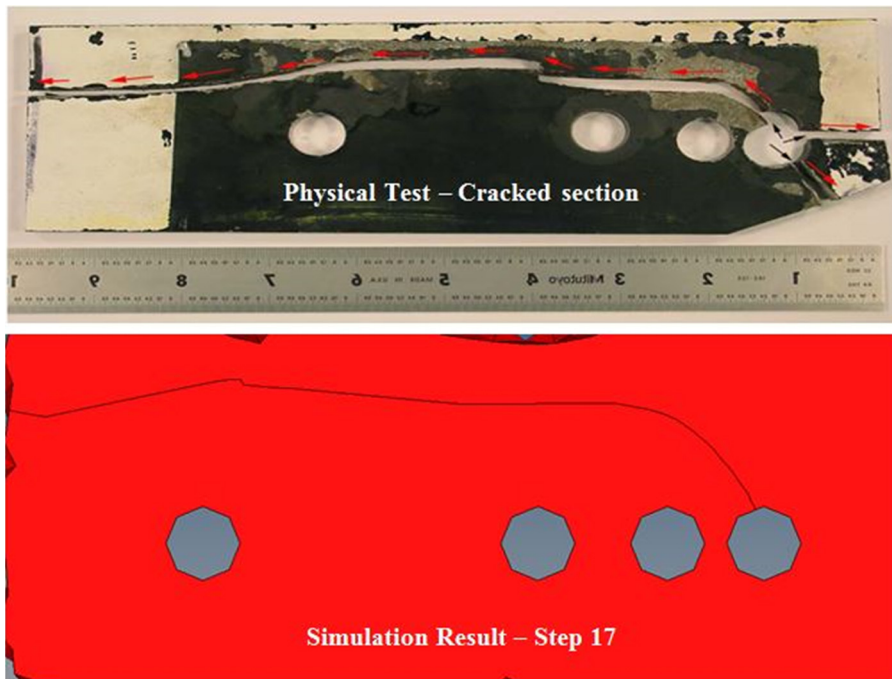
Fig. 10 shows comparison of crack path obtained between physical test and full vehicle response based 3D crack growth simulation result. It can be seen that the curvilinear mixed-mode crack path simulated has good agreement with physical test result. The primary crack path was observed to follow high stress zone as identified in simulation result, the secondary crack paths were not considered during simulation.

Fig. 10. Frame crack during physical test compared with simulation result obtained using full vehicle response based 3D crack growth process.

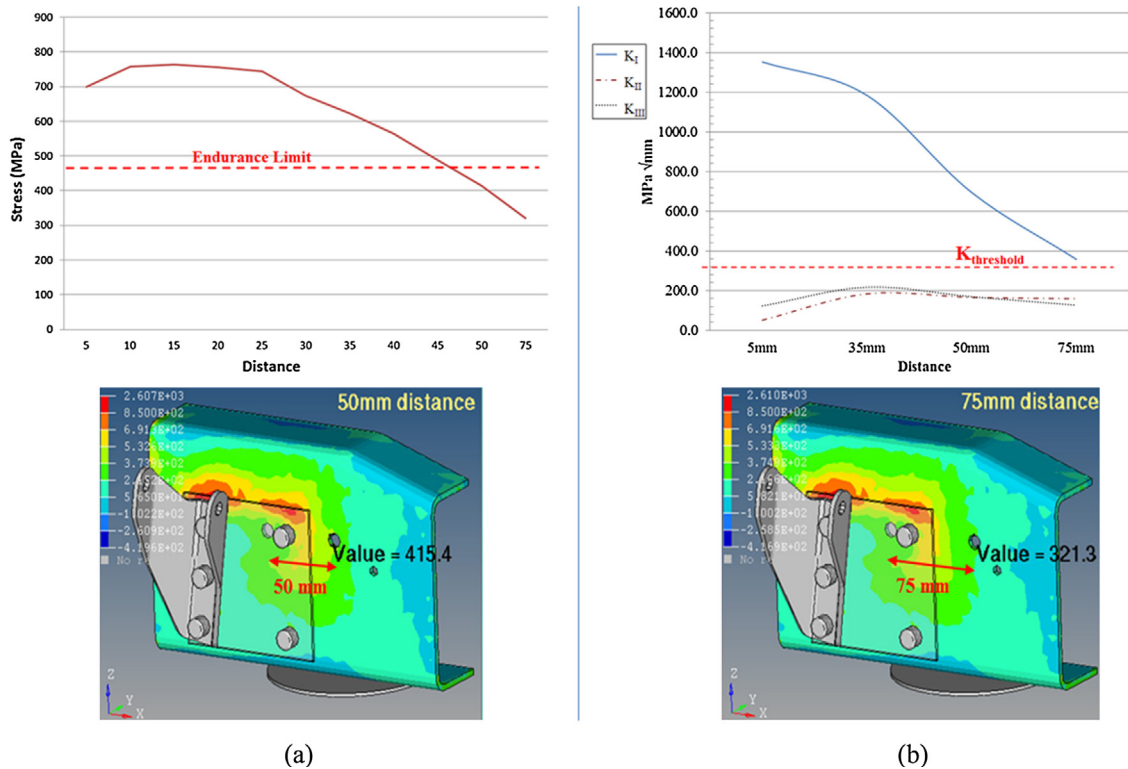
Fig. 12. (a) Safe life approach and (b) damage tolerant approach results for sensitivity study.

The endurance strength (1E6 cycles) of the frame was found to be  $2403 \mu$  (microns) [10] corresponding to a stress of 478 MPa. From the stress based design the allowable open-hole location was found to be around 45 mm from its initial location, as shown in Fig. 12(a). However the fracture mechanics approach was necessary to ensure a reliable location for frame holes.

The fracture mechanics approach involves inserting small semi-elliptical surface crack at different open-hole locations and extracting maximum stress intensity factors along crack fronts. It was observed  $K_I$  drops linearly with distance and approaches  $K_{\text{threshold}}$  at a distance of around 75 mm from its initial location. In Fig. 12(b),  $K_I$  remains above  $K_{\text{threshold}}$  at 45 mm and an aggressive open-hole would still lead to crack propagation under fatigue loading at that distance. This study provides a comparative view of two design approaches and helps identify a no drill zone on frame rails near high stress areas.
