# Case Studies in Engineering Failure Analysis

# Failure analysis of mixed mode crack growth in heavy duty truck frame rail

A failure analysis investigation was performed on a fractured heavy duty truck frame rail obtained during endurance track testing. The fracture observed was on the frame web within the torque rod connection to the rear drive axle of the vehicle. This section of frame experiences multi-axial loading conditions including out-of-plane bending, twisting and shear under road loads. Metallographic examination revealed micro-cracks on the edges of an open hole located in an area of high stress concentration. This manufacturing defect acted as a stress raiser and resulted in fatigue crack initiation. Simulation of crack growth on frame rail using dynamic loads from a full vehicle model was completed. After careful analysis it was concluded that the failure occurred due to an aggressively drilled open hole which created small crack initiations in a high stress-state location of the frame. This resulted in extensive curvilinear crack growth under dynamic loads of the vehicle.

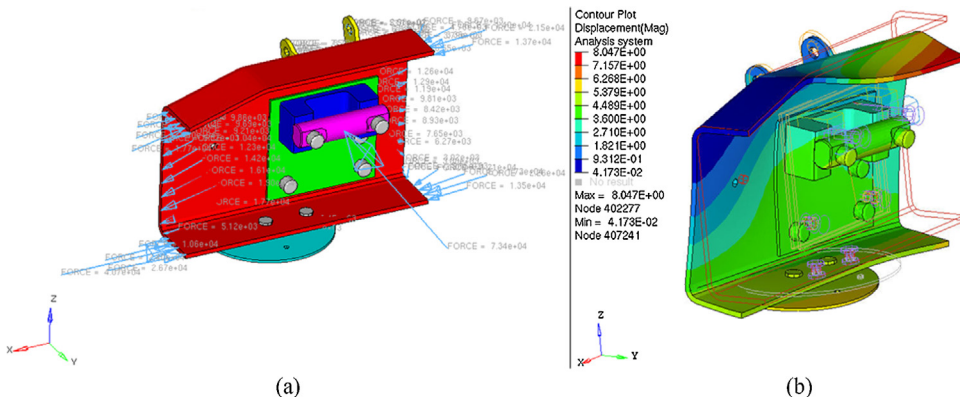
Fig. 6(a) shows the interface forces applied on the sub-model used for fatigue and crack growth simulation. The interface forces were applied on all the grid points defining the boundary of the sub-model with the full vehicle model. The loads were obtained from modal transient analysis of a full vehicle model for multi-axial test track excitations. Fig. 6(b) shows displacement plot indicating frame twist and bend modes obtained under multi-axial loading.

Fig. 6. (a) Multi-axial loading on frame section. (b) Displacement plot under multi-axial loads.

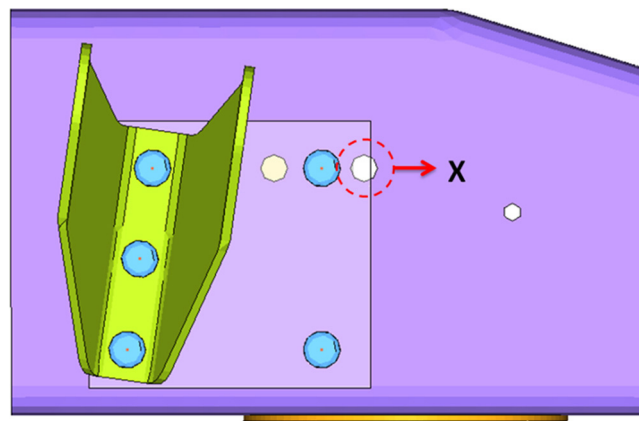
The objective of this sensitivity study was to determine the effect of moving the open-hole on frame that had been drilled close to an existing bolt (high stress area) further from its initial location in order to determine if maintaining a certain distance from the high stress area will be identified to prevent fatigue failure. In Fig. 11, description of design iterations performed for sensitivity study is shown. The frame open-hole was moved along “X” direction in multiple increments and the distribution of stress concentration near open-hole was studied. It is to be noted that frame holes are often drilled to mount brackets and for routing of hydraulics and electrical wires. This study helps identify no-drill zone based on both safe life and fracture mechanics perspective.

Fig. 11. Location of frame open-hole moved along “X” direction for sensitivity study.

The endurance strength (1E6 cycles) of the frame was found to be  $2403 \mu$  (microns) [10] corresponding to a stress of 478 MPa. From the stress based design the allowable open-hole location was found to be around 45 mm from its initial location, as shown in Fig. 12(a). However the fracture mechanics approach was necessary to ensure a reliable location for frame holes.
